# CEEAMA Live Wire E-NEWSLETTER

### Topic for June 2025 GIS SUBSTATIONS

Electrical Consultants Newsletter Volume No. 4 Issue #51 June 2025

## 420kV SF<sub>6</sub> Gas Circuit Breaker Interrupting Unit <u>FATAL ACCIDENT</u>

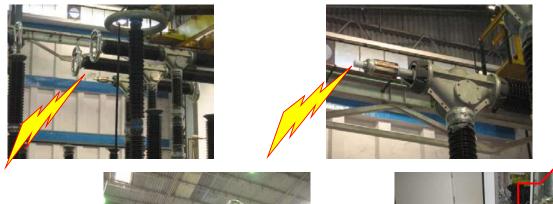
At the factory, the whole area of testing was found with splinters shattered across. Few CB poles around were also found to be damaged with these splinters.

Neighbouring area's glass partition was also shattered with a piece of the porcelain flying through. One of the high-bay lighting fitting was damaged. The roof of the factory was also found to be broken at 2 places where the splinters might have ripped through.

Management reported to have faced extensive wrath of workers (approx. 250). The news was spread in local newspapers, & TV channels. Later, PCB (Pollution Control Board) too came to know and had reached factory for investigation. Management had earlier informed to the factory inspector and had lodged police complaint as well. <u>Pictures showing extent of damage: Circuit Breaker – Interrupter Porcelain</u>

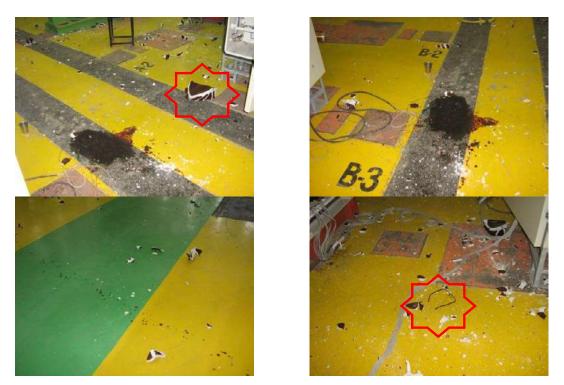
Pictures showing extent of damage: Blood marks of the deceased

Pictures showing extent of damage: spread of splinters, glass wall ripped through, High-bay fitting damaged

Any equipment under test which pose potential hazard must be cordoned off during tests. E.g. Porcelain can be provided with some net to contain the splintering. HV equipment can be cordoned to avoid any accidental touch. In the said incident, gas was removed from the CB of Y & B phases only. However, the neighbouring CBs which might have been damaged directly or indirectly also should have been analysed and gas evacuation, etc. must be carried out.

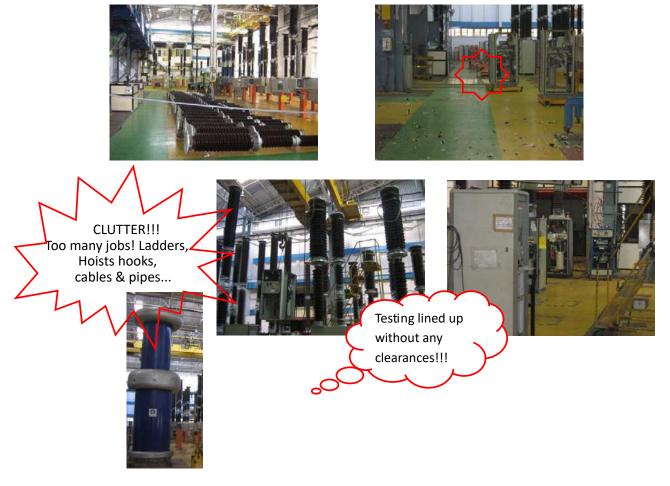
There must be provision of emergency exit doors at appropriate locations which shall be visible either directly or through EXIT signage. During the incident, most of the assembly staff working there (almost 25 of them) found it difficult to run off fast, immediately and far off due to obstruction of the various jobs under progress with their doors open. Surprisingly, the <u>investigator found that assembly was carried out even in passage way!</u> Gas Pipe laid on floor forms certain obstruction too for escape.

It was also found that the Testing room upstairs too do not have emergency exit. The 400kV CB should not be tested very close to this room either!

Pictures showing congested assembly / testing area / obstruction in escape route, etc.

Care can be taken on regular basis to avoid keeping of any hazardous, pointed, sharp material on ground or on the path of escape.
